BAYERISCHE MOTOREN WERKE  
AKTIENGESellschaft

Rundschreiben der Abteilung Kundendienst und Teile

Motorcycles: Group Rear Wheel Drive No. 1/62 (183) engl.

Drive shafts BMW R 25/3 - R 26 - R 27

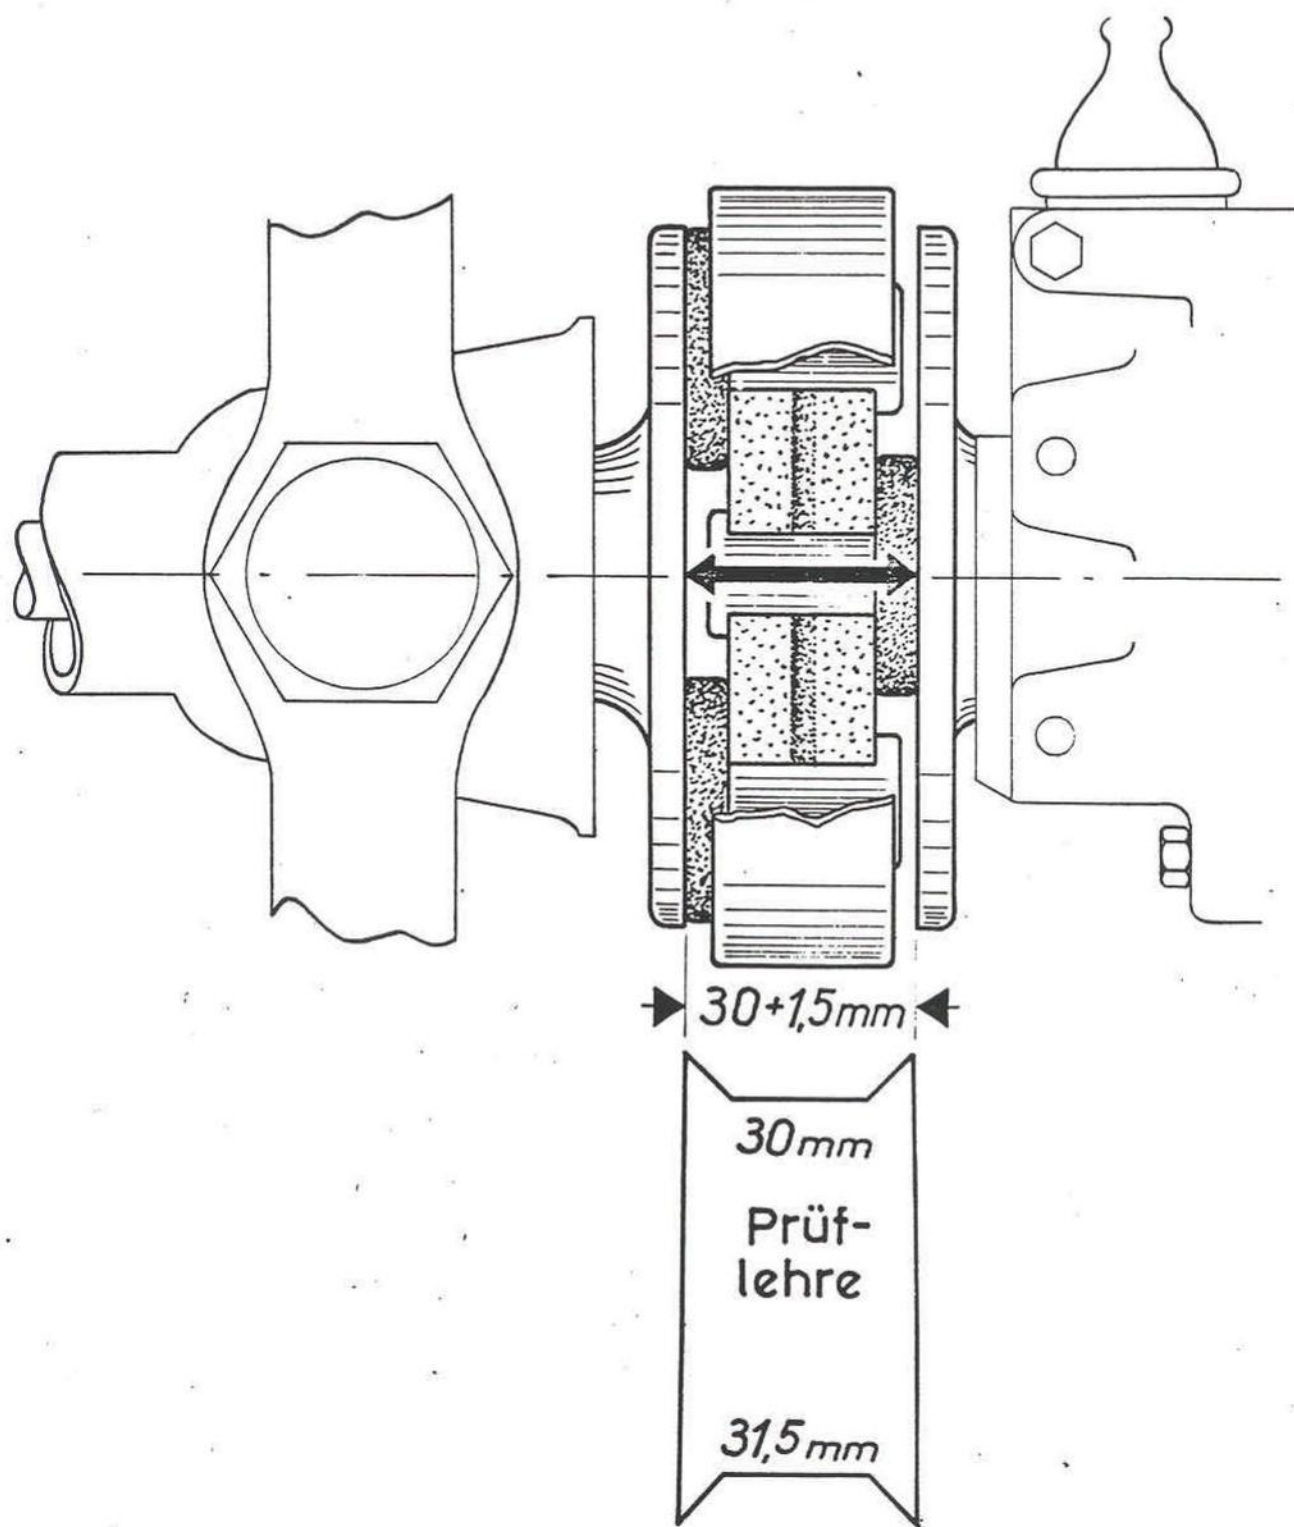
Rad ( 183 )

Occasionally we are receiving reports concerning drive shaft breakages on the motorcycle models referred to above.

the distance between the driving flange of the transmission and the mating flange of the drive shaft, measured with the drive shaft in horizontal position, amounts to  $30 + 1.5$  mm. ( $1.2'' + .06''$ ).

To check and adjust this distance we suggest that a checking gauge be made of a 3-4 mm. ( $.12''$  to  $.16''$ ) thick flat iron as per enclosed drawing. To prevent further damages, the above mentioned distance must, whenever a repair work has been carried out on the bevel drive or on the drive shaft itself, absolutely be checked and, if necessary, adjusted, loading the motorcycle for this so the drive shaft is in horizontal position and that the two flanges are thus parallel.

The necessary corrections, if any, should be performed,

on the R 25/3 type, by pressing the coupling flange up or downwards,

on the models R 26 and R 27 by means of spacing washers (shims).
