# COMMANDO SERVICE NOTES

**COMPLETE WITH ELECTRIC START**

Text - Tim Stevens, John Hudson

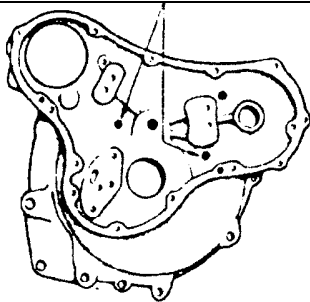
DRILL 3/8 Holes  
HERE

Diagram 4, Timing side crankcase showing holes for 850 breathing, See page 14.

The 830 breather is much better than both earlier systems, but really you need 830 cases to make it work, so that you get good oil return from the sump and a filter, but you can get good results by fitting a pipe of about 1/2 in bore into the back of the timing chamber where the magneto used to go (in the days when Lucas ignition systems were guaranteed for two years, including points wear). The pipe should stick through the case about 1/2 in and slope downwards, so that oil running down the inside of the case doesn't get carried up the pipe with the air going out. Oil runs down from the inlet valve as well as sloshing about from the timing gear. How you fit the pipe is up to you; you can't just buy the bits and slap them in. It is also necessary to drill holes in the timing side crankcase—try and get a look in an 830 timing cover and copy the size and position and I don't recommend drilling the holes without dismantling the engine; no Malcolm, put that brace and bit down immediately! See Diagram 4, page 12
