# BSA SERVICE SHEET No. 501

## "D" Group Engine and Gearbox (Exploded View)

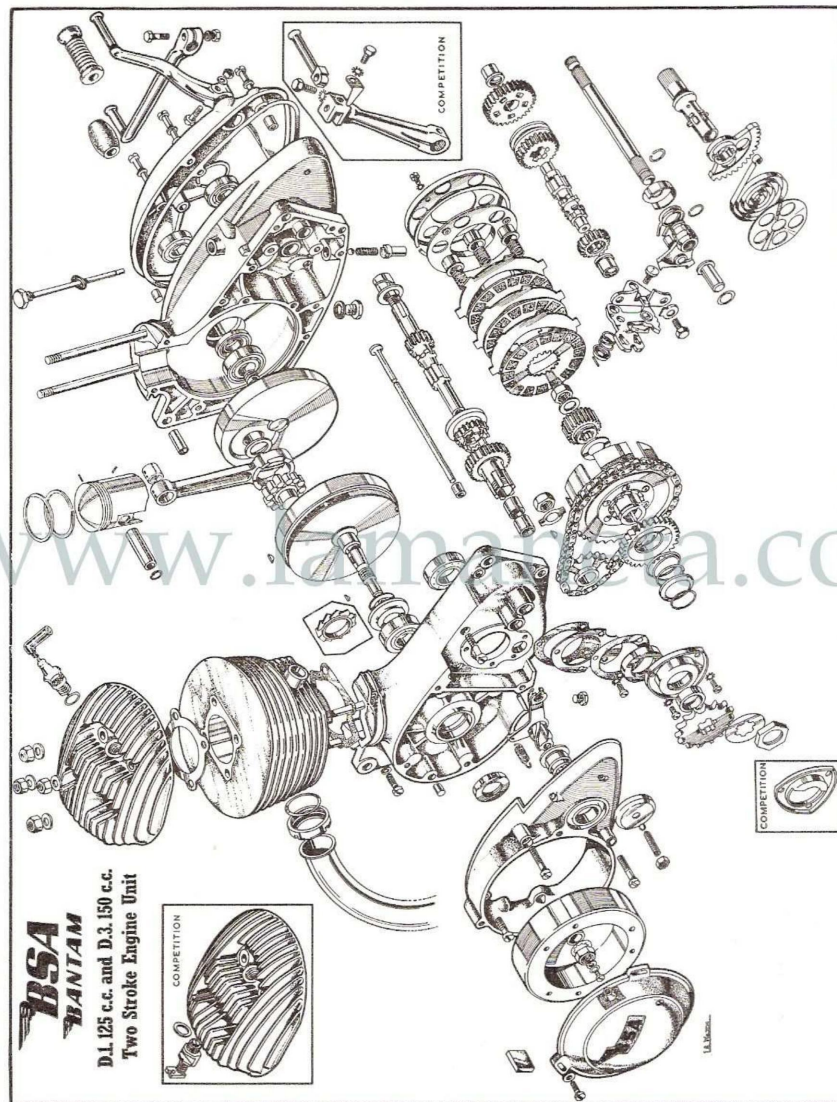
NOTE.—On DI engines after 1954, and all D3 engines, the offside Crankshaft Oil Seal is placed next to the flywheel instead of between the two bearings.
