# **BSA SERVICE SHEET No. 613**

## **"M" Group Models**

**FITTED WITH GIRDER TYPE FORKS**

## **ADJUSTMENTS TO STEERING HEAD AND FRONT FORKS**

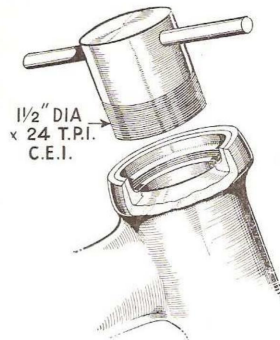
Fig. M44. Steering head ballrace extractor 61-1919.

The steering stem can now be driven out (downwards) with a lead hammer to prevent damage to the threads. The stem will bring with it the lower ballrace cone, leaving the cups in position at the top and bottom of the steering head. A simple extractor shown in Fig. M44 is used for removal of

inserted from the opposite end of the head lug, and the extractor and ballrace driven out together.

these cups. They are threaded to take the extractor, which should be screwed well home, since it engages with a few threads only. A bar is then
